Fish Passage & Diversion Screening Inventory Database Report Cover Sheet

Site Description Report

Level A Culvert Assessment Report

Fishway Assessment Report

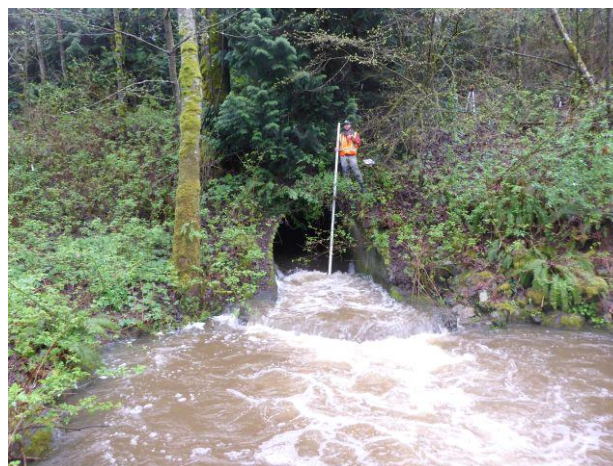
The 9.5 ft. diameter, 271 ft. long SPS culvert is equipped with 15 expansion-ring weirs and one concrete weir on the outlet apron. Five DS log controls step the streambed up to the culvert outlet. Excessive water surface drop was measured on a baffle.

Barrier: **Yes** Reason: **WS Drop** Passability (%): **67**

Fishway is under NB I-5. The stream is day lighted in the median and goes under SB I-5 in a low-gradient, passable box culvert with no baffles. The existing
